*Hyde Creek Community Centre  
Expansion - Port Coquitlam*

**PRELIMINARY EXISTING FACILITY REPORT**

## HYDE CREEK COMMUNITY CENTRE EXPANSION PORT COQUITLAM

Re.: PRELIMINARY STRUCTURAL REPORT FOR PROPOSED EXPANSION TO  
HYDE CREEK COMMUNITY CENTRE - PORT COQUITLAM, B.C.

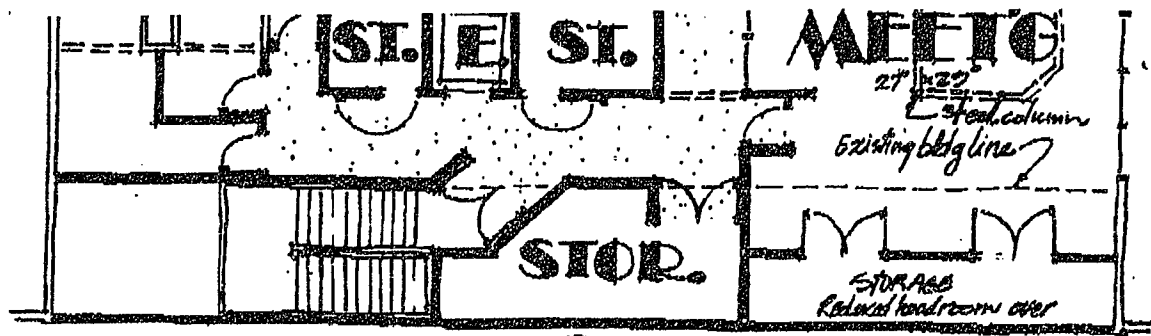
# UPPER FLOOR CONCEPT: 3.

- a) The mechanical room chimney was erected approximately 8 feet east of its assumed location. This should not materially affect any proposed work.
  - b) Existing steel columns at the second floor level were not originally apparent during the schematic design of the new layouts on this level. This can be resolved by some redesign of the affected rooms. A proposed revision sketch is attached.
